A Write-off at 6 m.p.h!

**Thatcham
Bumper
Ratings**

Thatcham Bumper Ratings

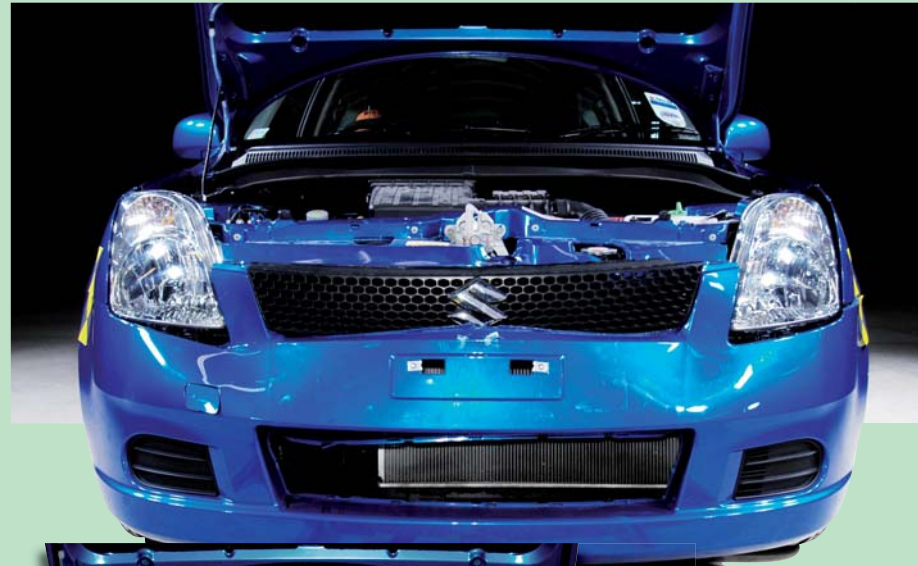
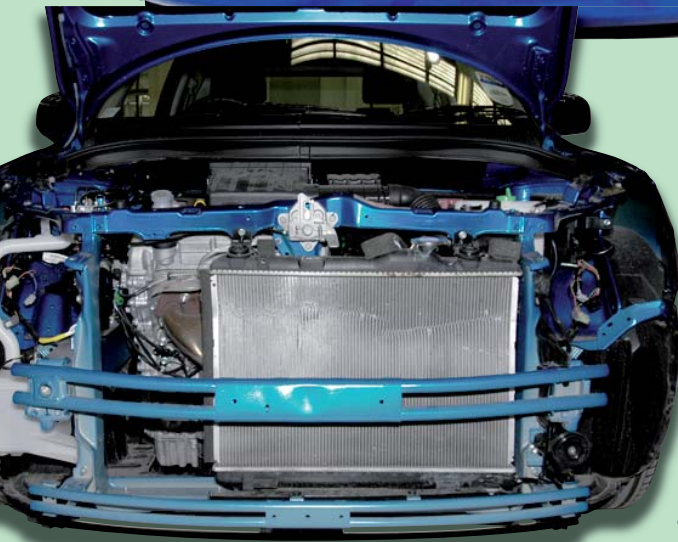
Suzuki Swift front **£2,300**: Top picture: with bumper cover in place. Bottom picture: cover removed to show bumper beam

In Thatcham's new bumper test, the Suzuki Swift was rated as the worst performer in the front test. With the highest repair cost of nearly £2,300 the car only achieved

a 'Poor' rating. This was due to the bumper beam being too flimsy and small, causing expensive damage not only to the bumper itself, but also to the grille, wings, bonnet, radiator and headlights. At the rear, the Suzuki Swift also received a 'Poor' rating, due to costly damage to the bumper, tailgate, fog light, and boot floor, amounting to another repair cost of nearly £2,300. The bumper systems on the front and

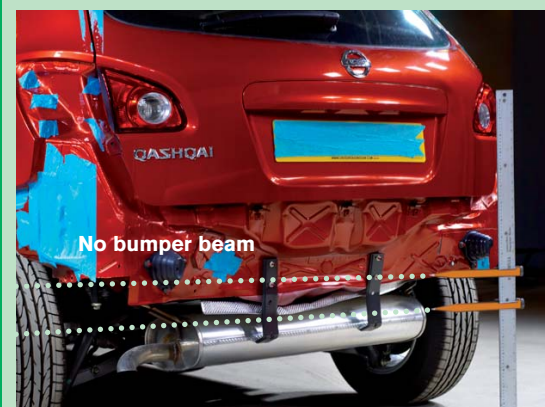
Nissan Qashqai: Poor bumper system with no bumper beam at all

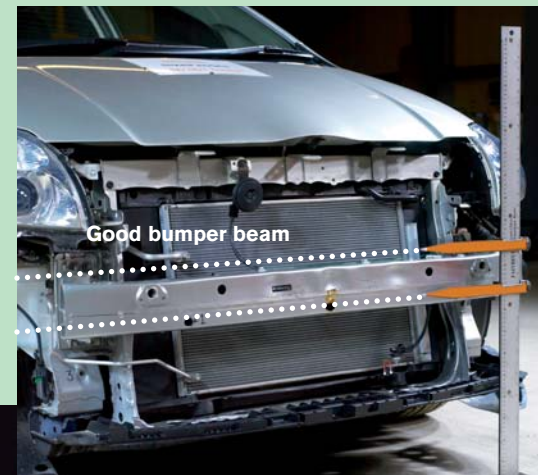
Toyota Auris: Good Bumper beam protecting the front of the vehicle

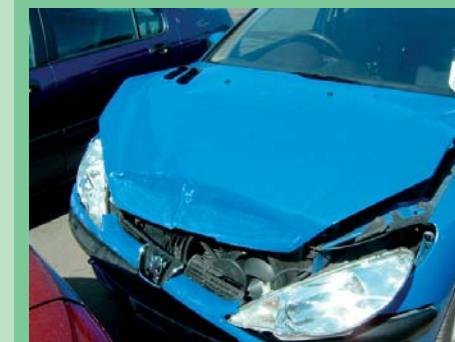
Real world underride crash

This is a common scenario and is often seen at the side of the road. One vehicle has run into the back of another but due to heavy braking, the bumpers slipped off one another. The front of the impacting car's bonnet is folded, its lights are smashed and it is often undriveable. However, the bumper appears to be largely undamaged.

The problem is that even where bumpers initially appear to engage during a crash, they often slip off one another. This is due to poor alignment of the beam structure or a very curved cover that promotes instability.

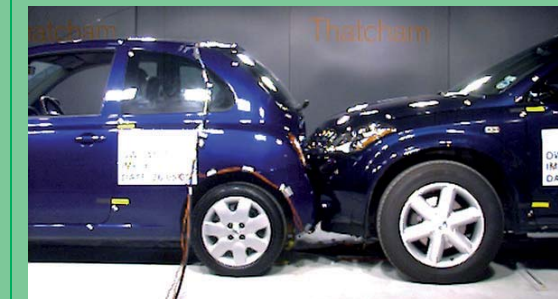
4x4's often override smaller cars causing expensive damage to both

Most 4x4s have a much higher bumper, so in a crash they 'override' an ordinary car's bumper, causing massive repair costs. But don't think that 4x4s are undamaged in this scenario. Often in a low speed crash, their repair costs can be disproportionately high, due to the high cost of vulnerable mechanical components under the bumper.

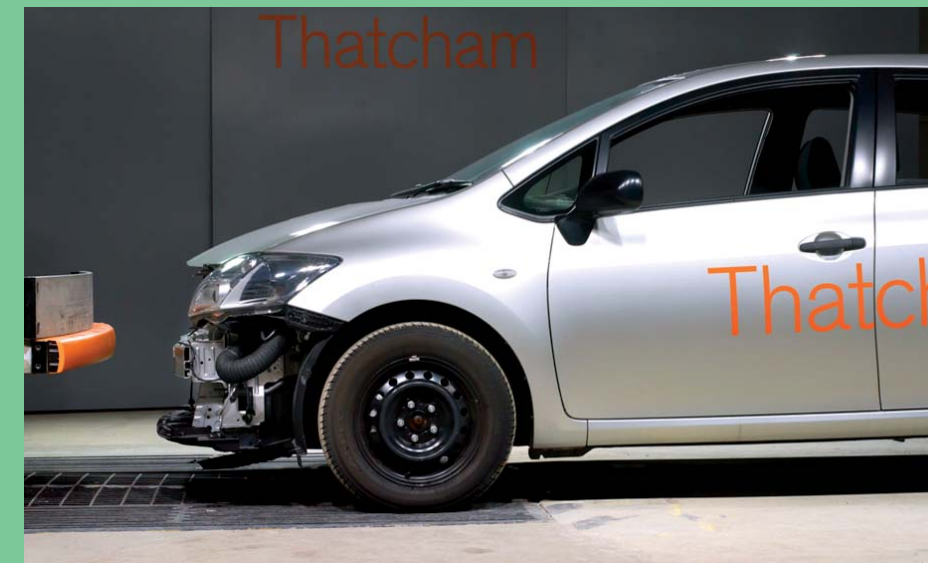
Front bumper test with bumper cover removed to show beam alignment

face, and this represents the upper structure of the impacting vehicle. The tests are run at 6 m.p.h. with the bumper barrier height set to 455mm from the ground for the front, and 405mm for the rear. This is to recreate the underride phenomenon seen in real world crashes and encourages the car manufacturers to produce tall bumper beams that are at least 100mm tall, and that overlap at front and rear. The RCAR test only recommends testing beams that are

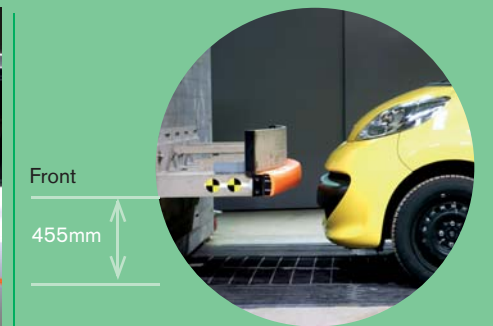
Front
455mm

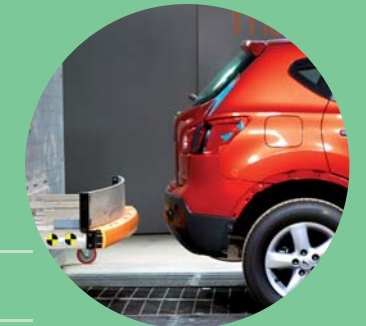
Rear
405mm

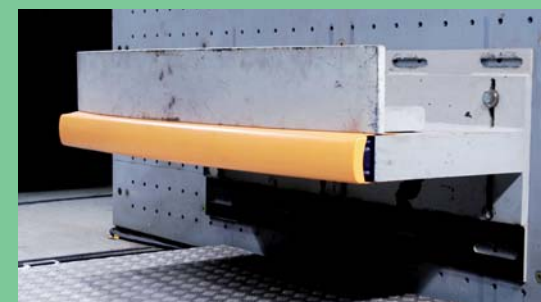
Bumper barrier

The Thatcham bumper tests are based on a new international standard bumper test from RCAR (the Research Council for Automobile Repairs). The test uses a standardised bumper beam that is 100mm tall with a flexible, energy absorbing cover that replicates a real bumper on a car. A backplate 200mm tall is fitted to the top surface of the bumper barrier, 25mm behind the front

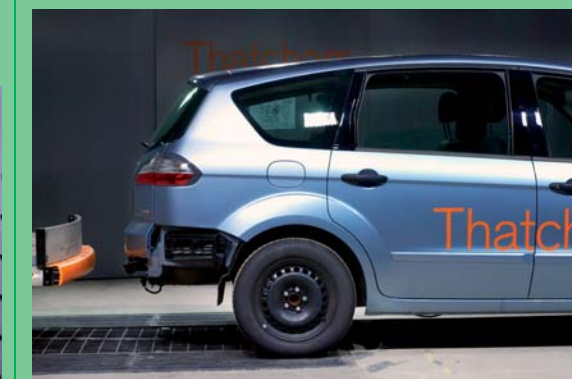
Rear bumper test with bumper cover removed to show beam alignment

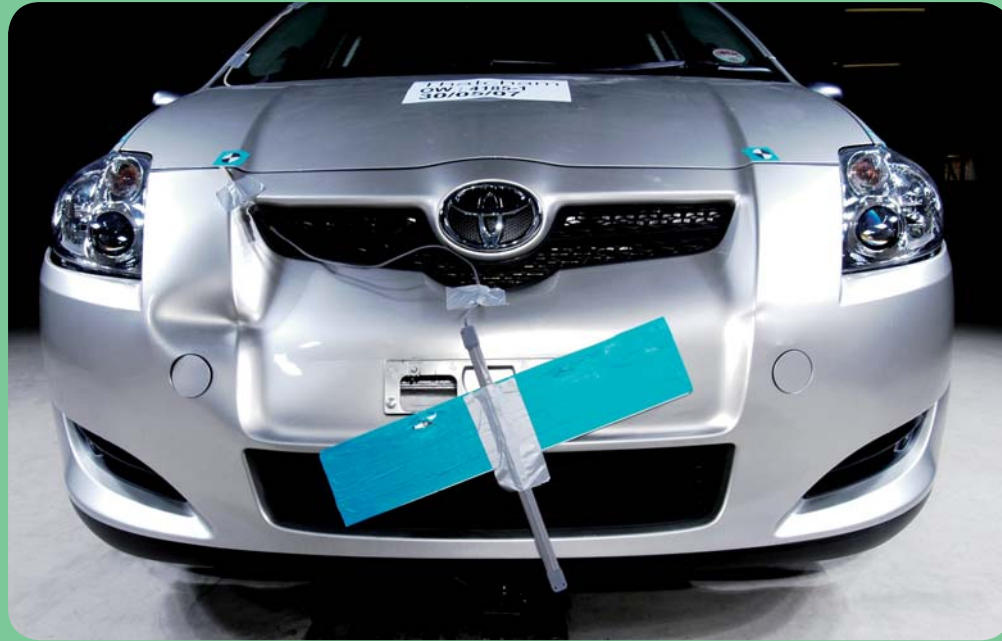
Toyota Auris front **£810**

The best performer at the front was the Toyota Auris with the lowest repair cost of **£810**. The Auris had stable engagement with the bumper barrier, courtesy of its deep bumper beam.

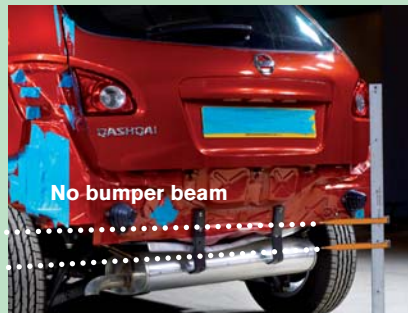
Override and no bumper beam: Nissan Qashqai rear **£2,830**

The worst performer at the rear was the Nissan Qashqai, which had no bumper beam fitted to the rear of the vehicle. Whilst the Qashqai achieved an 'Acceptable' rating for the front of the car, it was rated as 'Poor' at the rear and had the highest rear repair cost of the group at **£2,830**. The vehicle is inadequately equipped for damage protection in a low speed collision, even though its 4x4 appearance makes it appear rugged and strong.

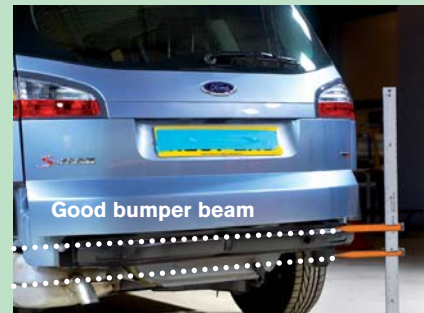
Ford S-Max: 'Good' bumper beam

The best performer at the rear was the Ford S-Max, which was the only vehicle to achieve a 'GOOD' bumper rating. The repair at the rear of the S-Max was low at only **£310**. This bumper beam was deep and was aligned with the bumper barrier, so that it engaged in a stable manner and did not slip off. However, the front of the S-Max only received a 'Marginal' rating with a repair cost of **£1,570**.

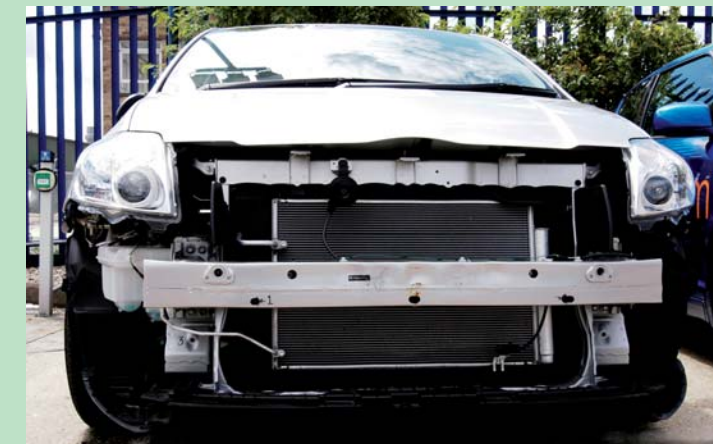
Toyota Auris: deep bumper beam

However, a 'Good' rating in the bumper test and a high lower leg score in the Euro NCAP test are not mutually exclusive. The Toyota Auris scored 3 out of 4 stars in the pedestrian ratings by Euro NCAP. On the lower leg test, the Auris scored 5.81 points, which is very close to the maximum of 6 points. The Auris had the highest rating in the front bumper test from the group of vehicles tested and it rated as 'Acceptable' due to its deep and well aligned bumper beam.

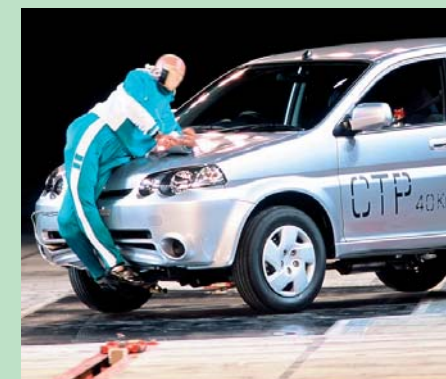
Honda pedestrian test

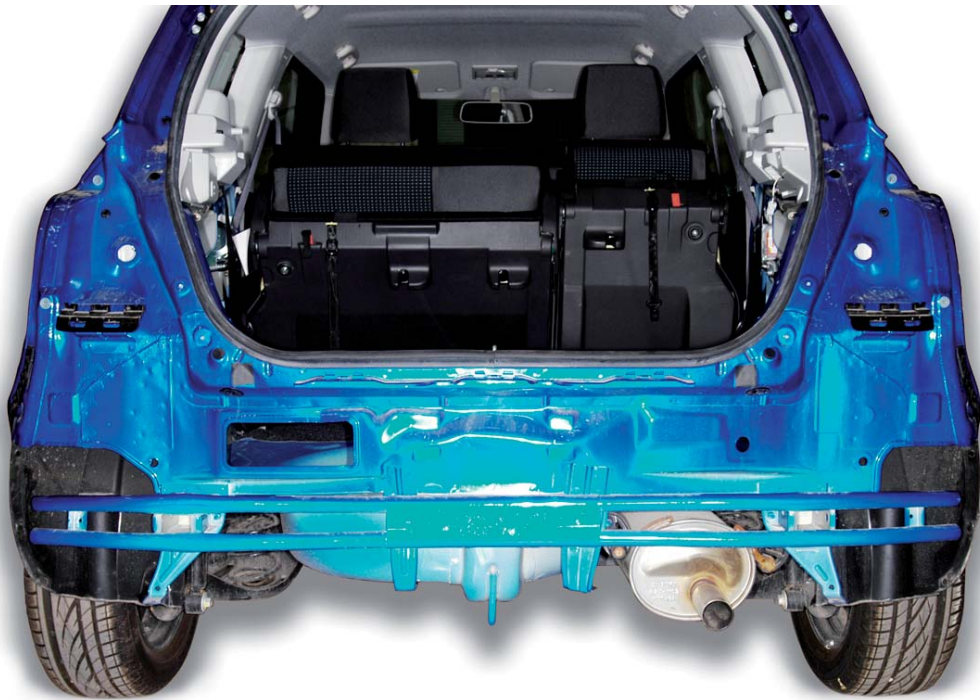
The Suzuki Swift has poor bumper beam design. It is too weak to protect the rear of the car. This leads to **£2,300** in repair costs, following a crash at only 6 m.p.h.
